Mitchell Park Horticultural Conservatory Task Force Meeting #1

October 12, 2016

Physical Structure Review

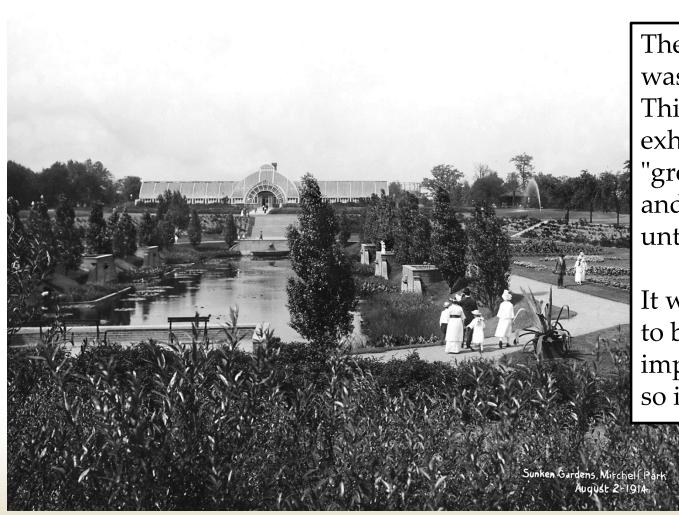
First Conservatory & Sunken Gardens

The first conservatory was built in 1898.
This conservatory exhibited flowers in a "greenhouse" setting and served the public until 1955.

It was determined to be unsafe and impractical to repair, so it was demolished.

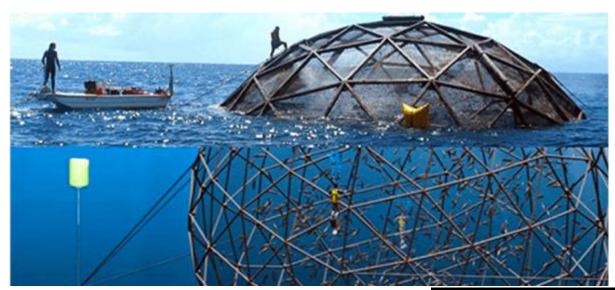
Geodesic Dome Construction

Geodesic Domes

- Underlying shape is spherical
- Windows can be same size
- Integrated construction, with window systems (frames) part of load-bearing structure

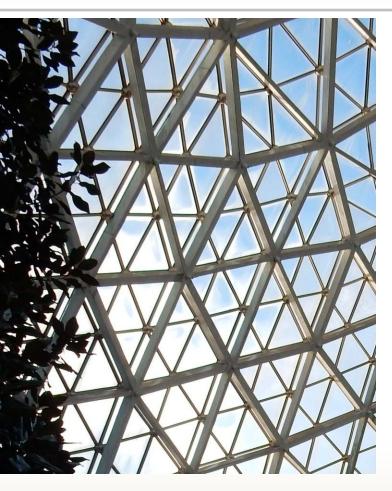
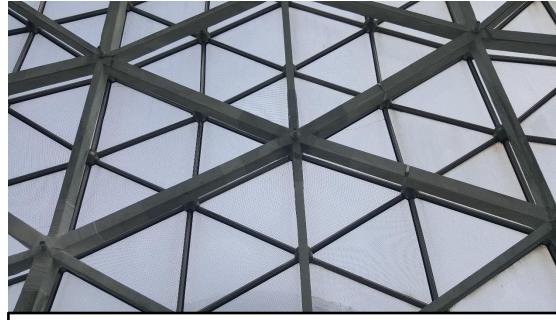
Mitchell Park Domes Construction

Conoidal Domes

- 'Bee hive' shape
- Windows will differ in size
- Mitchell Park Domes built in two layers: concrete structure and separate aluminum window system

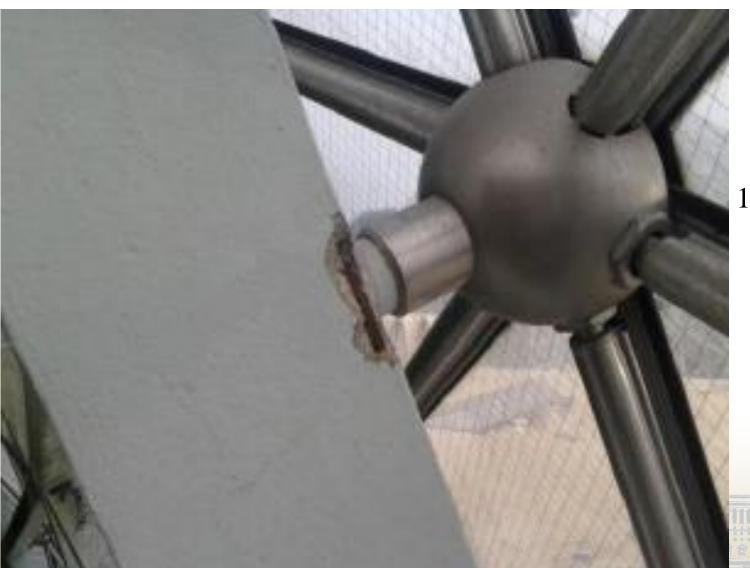
Aluminum / Concrete Hub Connection

5,100 Hub Connections 1,700 Per Dome

- 3. ~5,100 Hub Connections (aluminum to concrete frame)
 - Each a point of potential corrosion and spalling due to steel baseplate.
- 4. Drainage System internal to aluminum framing

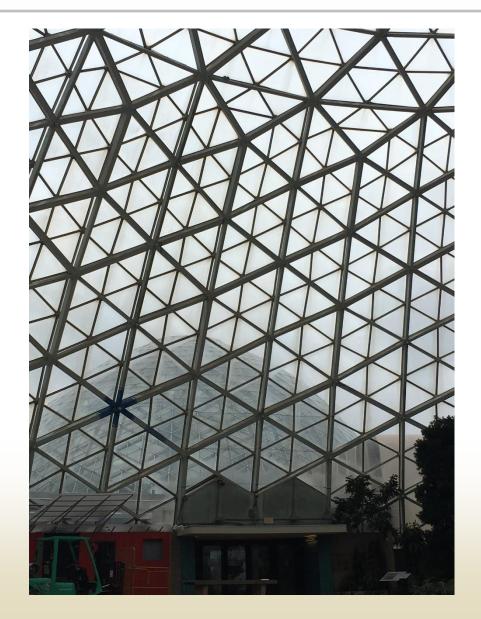
Protective Option: Wire Mesh

- Looked at range of options
 - Up to 5 year life span
- Show Dome and Tropical Dome finished; Desert Dome to be completed next month
- Mesh addresses falling concrete; does not "fix" structures
